# Zutari's duckbill design put to the test at Garden Route Dam

Zutari's spillway project at the Garden Route Dam was finally put to the test late last month when it began spilling following torrential rains in the area. The dam is the main supply for George in the Western Cape.

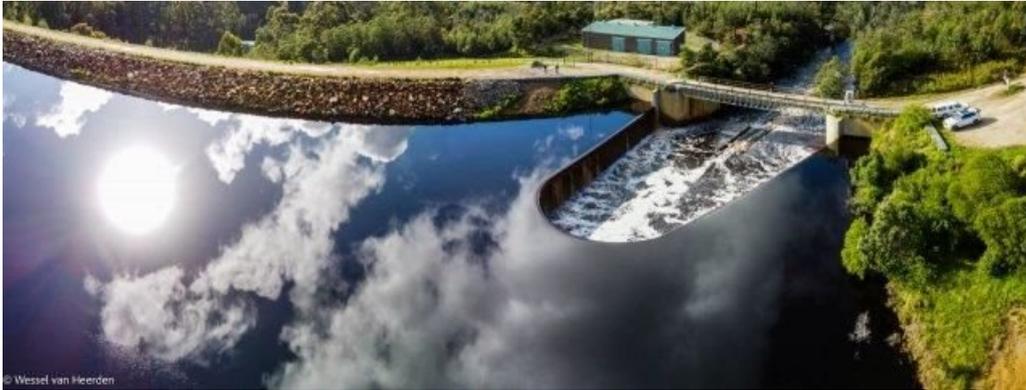
Zutari designed the duckbill-shaped spillway to slow down water flow using basic physics principles. Image: Wessel van Heerden

The project increased the existing storage capacity of the Garden Route Dam by raising its full supply level by 2.5m via the installation of a new spillway, enlarging the storage volume by 2.5 million cubic metres. The solution centred on a hydraulic design in the form of a non-linear spillway in the shape of a duckbill. Although duckbill or bathtub spillways are not unique, they are rare worldwide.

The Zutari team amended the hydraulic design to ensure that the weir would behave in a safe and predictable manner. The shape of the duckbill causes flow on opposite ends of the overflow flow to collide within the duckbill, causing an upwelling, also known as flow bulking, which breaks the flow's momentum and causes it to lose its energy. The flow from the rounded upstream end of the spillway is not so opposed and causes this upwelling of flow to move toward the exit of the spillway at rapid velocity. This increase in velocity reduces the water level to a lower elevation such that it can safely pass under the bridge over the spillway.

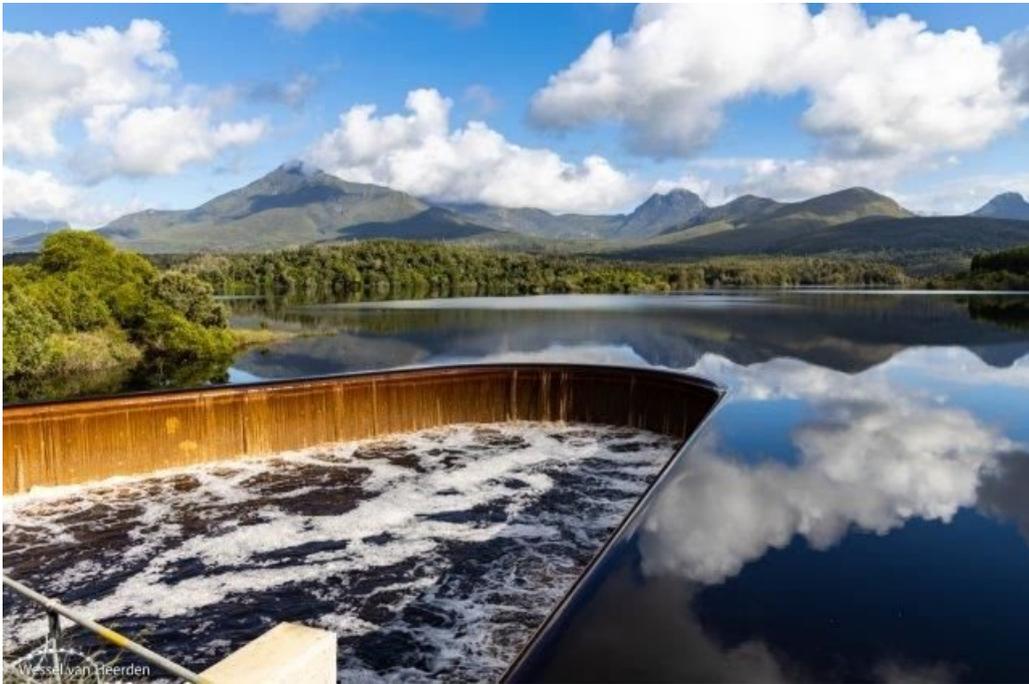
The new spillway overflowed on 22 November 2021. Image: Wessel van Hæerden

The final duckbill spillway design resulted in a total spillway length of 80m, with a maximum discharge capacity of 570m<sup>3</sup>/s at a freeboard of 4.1m. The flood event on 22 November was the first time the new spillway overflowed since its completion in December 2019. Prior to the flood event, the water level in the dam was roughly 1m below the crest of the spillway. This volume was rapidly filled up in the course of the early morning and the spillway started overflowing at roughly 8.30am. The peak of the flood occurred at 1pm, according to the Department of Water and Sanitation's water level-data record.

The water level recorder logged a maximum overflow depth of 0.509m over the crest, which equates to about 50m<sup>3</sup>/s in discharge. This thus appears to have been a relatively minor event, with the dam designed to cater for much higher flows. That said, the incoming flood was partially attenuated or absorbed by the storage volume in the dam basin. The flows at the nearby flow logger on the Malgas River likewise recorded a minor flood.
